**TAUNTON RIVER BASIN
TAUNTON, MASSACHUSETTS**

**MILL RIVER DAM
MA 00813**

**PHASE I INSPECTION REPORT
NATIONAL DAM INSPECTION PROGRAM**

APRIL 1979

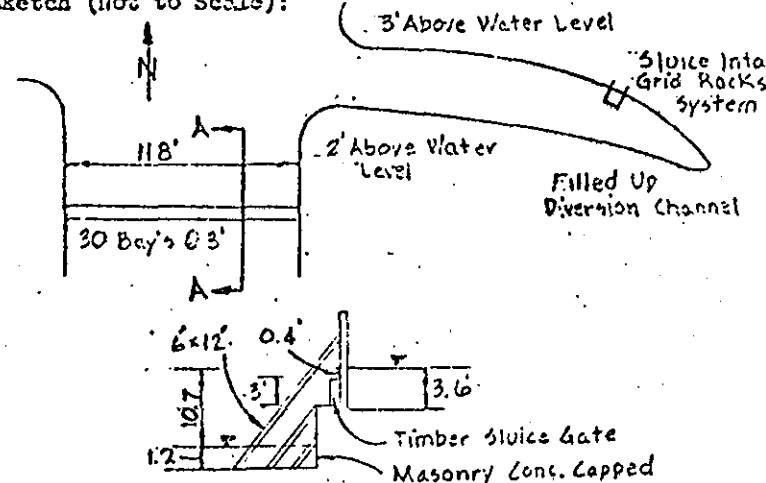
Rate Of Annual Replacement: 3 Sluice Gates Plus Any Other Repair.			
Remarks and Recommendations: Should be examined structurally and hydraulically. 6x12's appear okay, but timber supporting lower portion of dam could not be appraised. It is reported to be in poor condition. Overflow capacity may be adequate but should be checked since not more than 2 foot freeboard is available. Recommend opening sluice gates to lower pond level and reduce pressure on dam. Flooding of 1 foot in cellar during 1955 flood. The Whittenton Mfg. Co. owns all water rights above this dam.

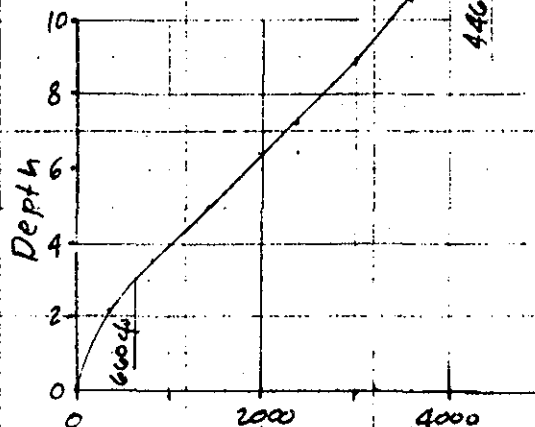
Failure under above test conditions raises depth at bridge from ± 3' to ± 14', with a minor flow over Whittenton St. 14 ft depth @ bridge equals elev. ± 60, which is only one foot below the assumed level in the pond. The street embankment would act as a secondary dam, limiting discharge downstream.
